Avoiding and Managing the Failure of Conventional Crowns and Bridges

Dent Update 2012; 39: 78–84

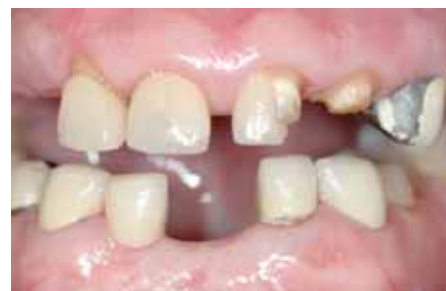
Figure 1. A patient with likely parafunction showing evidence of failure of both adhesive ceramic and conventional fixed restorations.

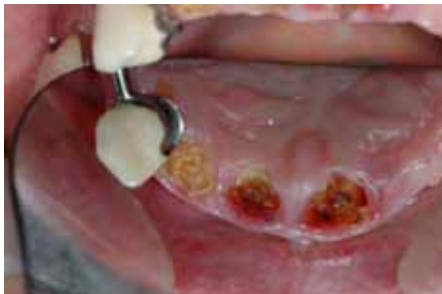
outlive the patient, they will eventually fail. The commonest cause of crown and bridge failure is caries^{5–8} (Figure 2). Many restorations will also fail as a result of de-cementation, or partial de-cementation in the case of bridges. For many bridge failures it is difficult to know whether de-cementation of an abutment preceded the caries or not. The authors consider that partial de-cementation and the

Figure 2. Gross secondary caries evident after removal of conventional crowns at UR1, UR2 and UL1. The patient will need a different restorative strategy to restore these teeth successfully.

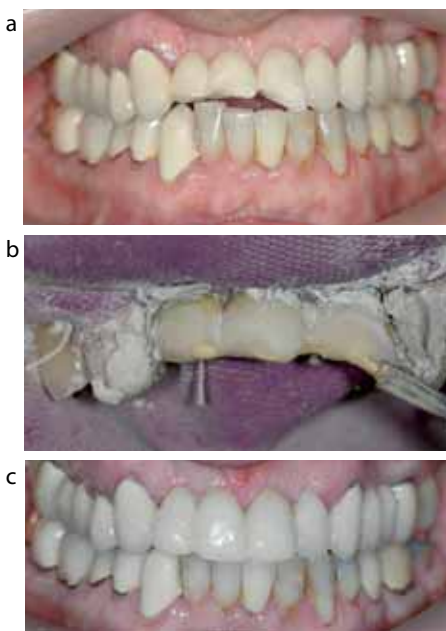
Figure 3. (a) Case 1: A frontal view of the patient described in Case 1 which illustrates fracturing of the veneering ceramic of UR1, UR2 and UL1. (b) Application of Sinfony™ Opaquer (3M ESPE) to the metal sub-structure of the bridge after intra-oral sandblasting. (c) Post-operative review of direct Gradia composite (GC) to mask the fractured ceramic.

presented with a fractured 10 unit PFM bridge extending from the UR4 to the UL6. The fracture was limited to the veneering ceramic of UR1, UR2 and UL1. The damage was caused by a fall and there was no evidence of damage to the rest of the restoration. The abutments were healthy with no evidence of de-cementation. The patient's major concern was the aesthetic impact of the damage. Following discussions with the patient, which included an explanation of all treatment options, it was decided to accept the existing fixed restoration and attempt a repair of the fractured ceramic with direct resin. The patient realized that, if this treatment proved unsuccessful, the maxillary anterior bridge would need to be removed to allow careful investigation of the abutments to plan for future treatment.

Case 1 (Figure 3 a–c)

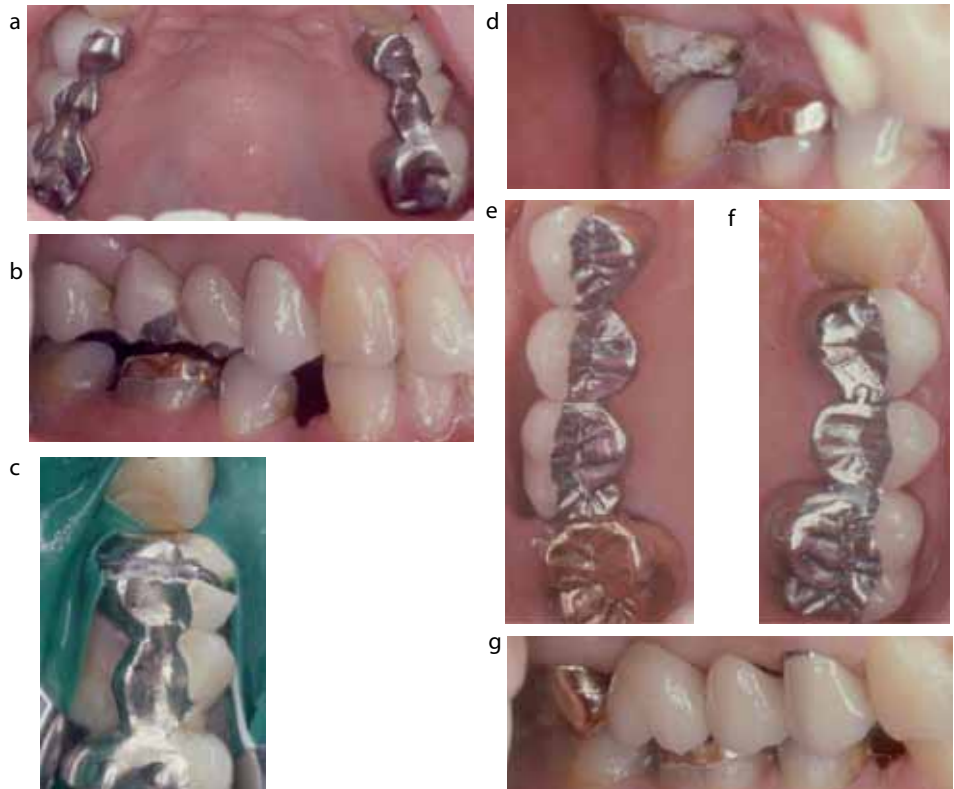
Figure 4. (a) Case 2: Maxillary occlusal view. The 3-unit fixed-fixed conventional porcelain fused to the metal bridge in the upper left quadrant replaced UL5 with a fracture of the ceramic on the pontic. The 4-unit fixed-fixed conventional bridge of the upper right quadrant replaced missing UR56. The right bridge displayed ceramic fracture on the labial aspects of the UR56 pontics. (b) Buccal aspects of the UR56

pontics. Existing ceramic fracture likely to reflect parafunction and inadequate metal support. (c) Clinical view of the bridge of the upper left quadrant after sectioning and prior to removal and investigation of UL46. Occlusal and palatal sectioning of retainers was achieved with a diamond bur for the porcelain and a new fluted tungsten carbide bur for the metal. The authors never recommend 'tapping off' conventional bridges as this is likely to lead to significant irreversible damage to the teeth and cores beneath. (d) The bridge in the upper right quadrant has been removed but occlusal contact between the UR7 and LR7 remains. The problem was resolved by further occlusal adjustment of UR7 and prescription of metal for the occlusal aspect of the future retainer (gold crown with pre-ceramic solder to UR6 pontic). Note some over-eruption associated with the LR6. (e) The same patient as above after cementation of the new posterior bridge in the upper right quadrant. Note that the bridge has been re-designed to incorporate a full veneer precious metal crown which has been soldered to the PFM elements of the bridge. This design allowed less tooth reduction on occlusal and buccal aspect UR7. Current evidence confirms that tooth preparation for posterior PFM accounts for approximately 76% of the coronal tooth structure.²⁶ (f) Cementation of the replacement bridge in the upper left quadrant. Note that the bridge has been re-designed to incorporate a movable joint between the pontic and the mesial abutment. The authors recommend an F/M joint where there is a significant difference in the likely retention offered by the major and minor abutments. The female slot should be placed within the distal aspect of the minor retainer and the male portion integral to the mesial aspect of the pontic. Metal ICP stops on metal surfaces of bridges and buccal ceramic are appropriately supported by underlying metal. (g) Buccal view after cementation of the bridge in the upper right quadrant. Note that the patient agreed to have a metal margin at the collar of the UR5 retainer (favourable lip line) which allowed the clinician to remove less tooth tissue in the cervical area. Metal collars on PFM crowns/retainers outside the aesthetic zone are acceptable to all but the most aesthetically aware patients.

A 40-year-old female patient presented with two maxillary posterior PFM bridges that displayed ceramic fracture. She was unhappy with the resultant cosmetic impairment and the visible dark areas of the underlying metal. The bridges had been *in situ* for approximately 10 years and had always been slightly uncomfortable since cementation. She gave a history of possible parafunction. There was no evidence of de-cementation or pathology associated with the four abutment teeth. The thought processes of the treating clinician included:

Case 2 (Figure 4 a–g)

- Why has the ceramic fractured and what am I going to do differently to ensure that a similar problem does not happen with a new restoration?
- How am I going to remove the restorations safely and ensure that I can make and fit good quality provisional restorations?
- What future designs will I use for the replacement bridges and will the patient accept cervical metal collars and metal occlusal surfaces?

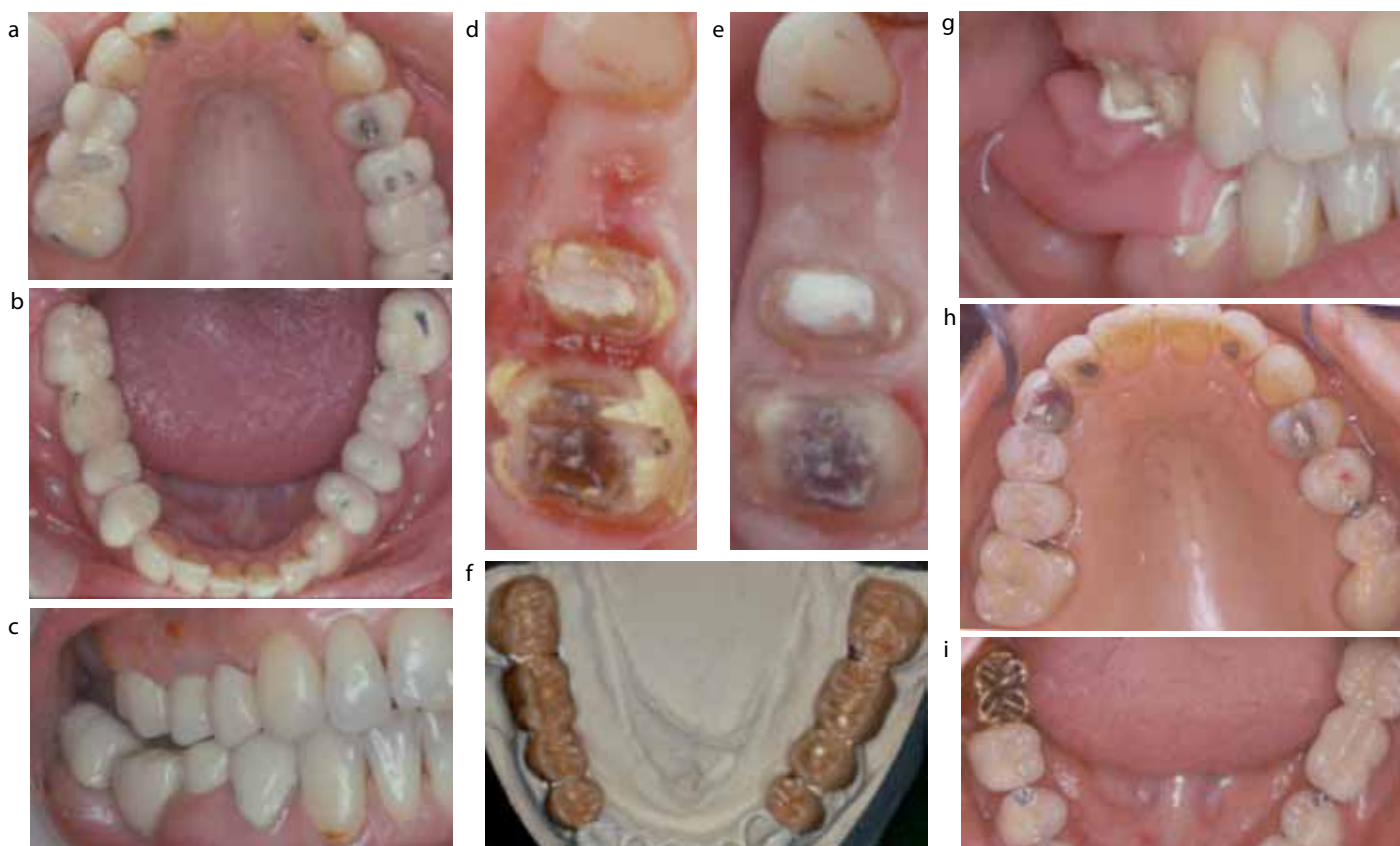
Figure 5. (a) Case 3: Upper occlusal view showing two posterior PFM bridges in the upper arch. (b) Lower occlusal view – the lower left quadrant restored with a 3-unit fixed-fixed conventional bridge. The lower right quadrant was restored with a 4-unit conventional bridge. (c) A right buccal view illustrating a lack of occlusion and posterior function of the upper and lower PFM conventional bridges on the right-hand side. The patient has an endodontic sinus from the failed RCT of the UR5. There was arrested bucco-cervical caries on the LR3 and areas of localized plaque-induced gingivitis. (d) Occlusal view after removal of the bridge in the upper right quadrant to allow investigation of UR56. Note gingival inflammation around the UR56 and the lack of occlusal height with UR5. (e) Occlusal view after crown lengthening surgery and temporization of UR56. The UR5 also required apical surgery. Note that the UR3 is unrestored and therefore amenable to act as an abutment tooth for a predictable adhesive bridge. (f) Full contour diagnostic wax-up created prior to removal of bridges. Also used to construct indirect provisional restorations. (g) Right buccal view after investigation and restoration of the abutment teeth. The patient had temporary bridges *in situ* for three months to make the best assessment of the modified occlusal scheme. Definitive bridges were placed on the right side first. An interocclusal record was taken with Micro-Beauty Wax (Moyco, USA) which was only supported by the prepared posterior teeth on the right side. The anterior natural teeth and the left provisional bridges stabilized other areas of the occlusion during the right jaw registration, which was further refined by reline with TempBond (Kerr Dental, UK). (h) Upper occlusal view of the fit and adjustment of the restorations in the URQ. Note the distal cantilever adhesive bridge replacing the UR4. The occlusal aspects of UR45 will be polished once the occlusion is appropriate. The UR4 has been restored with a distal adhesive bridge from UR3 which allows the root-filled UR5 to be restored as an individual crown. Upper left quadrant has been redesigned with fixed-movable restoration. The ‘bottomed-out’ female portion of the joint is placed within the distal aspect of the minor retainer (UL5) and the male component is part of the anterior aspect of the pontic. (i) Lower occlusal view after final cementation of the definitive bridges. (j) Anterior view after review of replacement crowns and bridges. Note that the sinus has healed at UR5. Pre-operative discussions confirmed that lip line allowed patient to accept metal collars.

This female patient was referred with pain and infection under her conventional bridge in the upper right quadrant and an inability to make occlusal contact and function with her posterior bridges. The patient was a medically well 50-year-old. Figures 5 (a–j) outline the practical steps of investigating the status of underlying tooth tissues and improving

(with the aid of crown lengthening surgery and endodontic revision) the quality of the support for replacement restorations. The success of this case relied on the correct planning and execution of static jaw registration.

Case 3 (Figure 5 a–j)

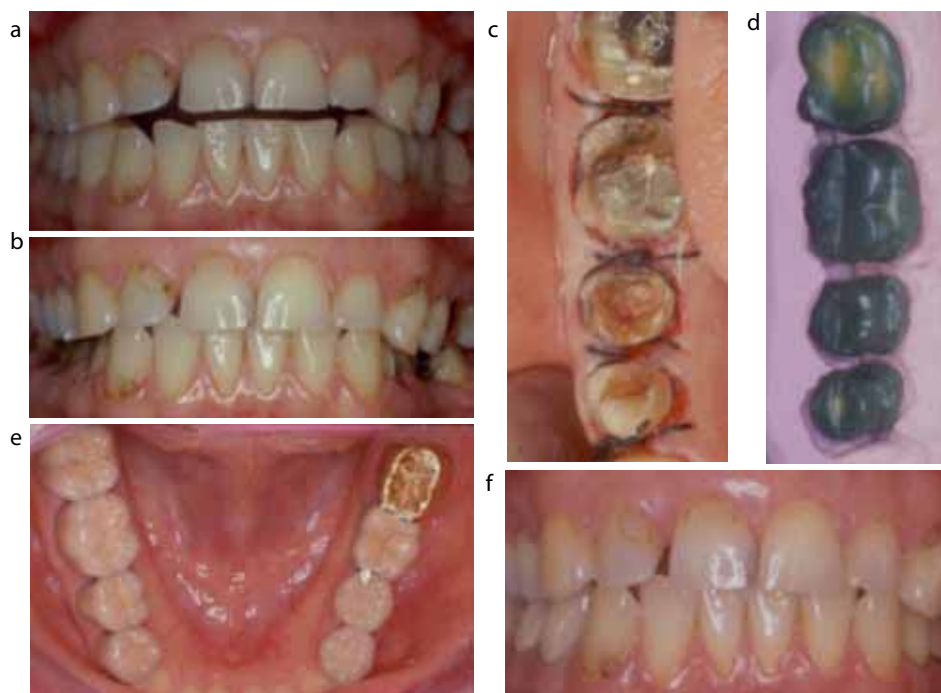
Figure 6. (a) Case 4: Anterior view – the patient had a partial coverage splint that extended from UR2 to UL2 and was worn constantly. The patient presented with an anterior open bite and contact on her posterior teeth and temporary posterior restorations only in her inter-cuspal position (ICP). Thin unreliable provisional restorations were *in situ* on the LR4567 and LL457. (b) The lower posterior temporary restorations were removed to allow contact between the anterior teeth at a reduced vertical dimension. At this vertical dimension the patient was comfortable and able to display lateral and protrusive guidance on the natural anterior teeth. It was also felt that this relationship would aid the fabrication of the posterior restorations. (c) Occlusal view showing the LR4567 after crown lengthening surgery which was needed to improve their clinical crown height. Note that the root-filling of LR5 was exposed to oral fluids. (d) 'Cut-back' wax-ups for the metal substructures of new PFMs for LR4567. A pink putty matrix was taken of the full contour wax-ups. This ensures optimum design, thickness of metal and support of future ceramic. (e) Lower occlusal view after cementation of definitive restorations. The patient requested tooth-coloured occlusal surfaces where possible. Individual PFM crowns were placed on LL4 and LR4567. The bridge in the lower left quadrant was redesigned to incorporate a movable joint into the posterior part of the LL5 with PFM full coverage minor retainer and a pre-ceramic soldered full veneer precious metal crown as the distal major retainer. (f) Anterior view at 24 months after placement of her definitive mandibular restorations. The patient was able to contact her anterior and posterior teeth in her ICP.

This case represents problems that can flow from over zealous technical treatment of temporo-mandibular dysfunction (TMD). The questions asked by the treating clinician included:

Case 4 (Figure 6 a–f)

- Is the TMD under control?

- At what vertical dimension will I be able to get anterior tooth contact and how much occlusal space will there be for the posterior fixed restorations?
- Will there be enough remaining tooth tissue to provide predictable fixed mandibular restorations?
- I will be short of occlusal height at LL7 – can I get the patient to accept metal occlusal surface on this tooth?
- Does the patient realize the difficulty of her treatment and the time and effort that will be involved in improving her situation?
- Is the patient happy to wear a splint after completion of treatment?
